Natural History of the Gila Symposium

An Overview of Aridland Ciénagas, with Proposals for Their Classification, Restoration, and Preservation

A.T. Cole and Cinda Cole

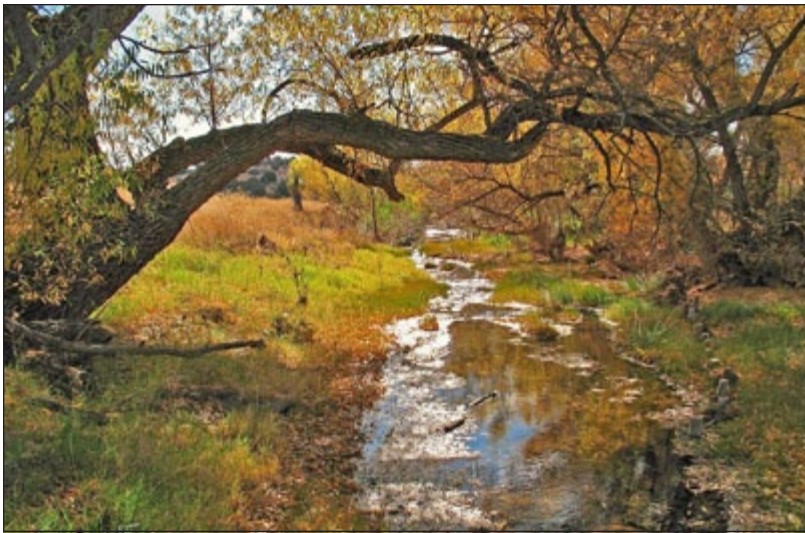
Fig. 1. Looking down-channel, creek-like portion of the Burro Cienaga, Pitchfork Ranch, Grant County, in southwest New Mexico. Photo: Dennis O'Keefe (2008).

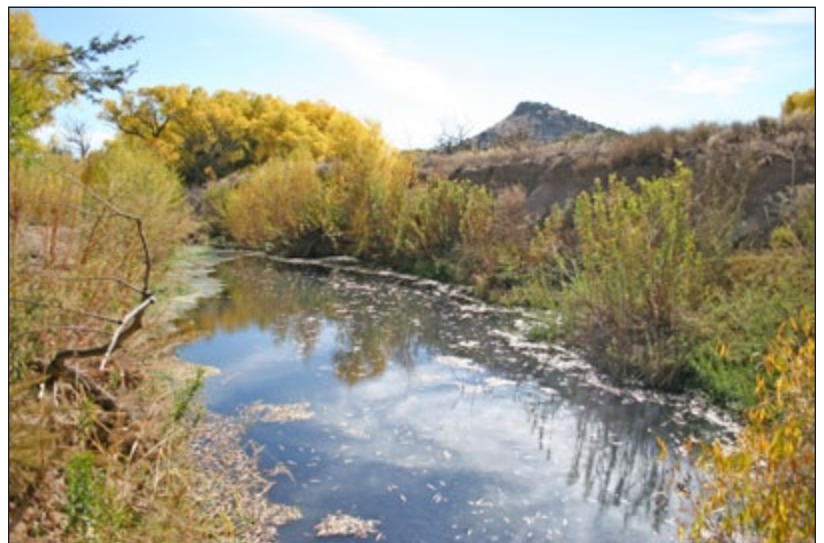
Fig. 2. The eight-foot wall shown here, down-channel right, is typical of the incision damage in many *ciénagas*. This pool, not a typical feature in a healthy *ciénaga*, is located in kilometer 1 of the 14 km (9 mi) Burro Cienaga reach on the Pitchfork Ranch. Photo: Cinda Cole (2005).

Many ciénagas also suffered damage when early settlers recontoured the broad ciénaga canyon flats in a misguided attempt to prevent the flooding of their agricultural fields. The Pitchfork Ranch has two of these recontoured and now abandoned fields (Fig. 3). Throughout the Southwest, remnant ditches, dikes, and dams persist today throughout many of the old canyon fields near the few remaining and poorly functioning ciénagas (Minckley et al. 2012). The resulting channelization and concentrated flow have reduced these historic wetlands to a fraction of their original size and inadvertently created deep, high-walled incisions that have progressively worsened—though most farming has long since ceased—and lowered the groundwater table even more, further dewatering formally wetted ciénaga habitat (Fig. 2).

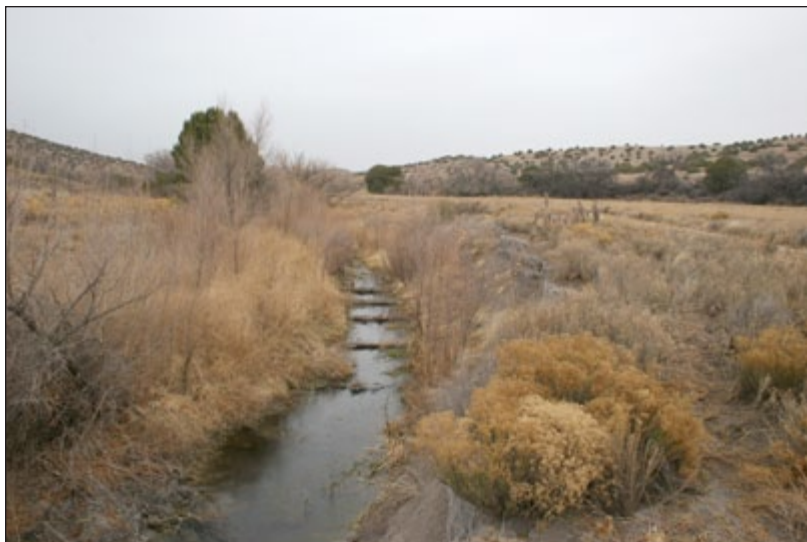
Fig. 3. Looking up-channel, a short section of the approximately 3.2 km (2 mi) *ciénaga* portion of the 14.48 km (9 mi) reach of the Burro *Ciénaga* (full course is 747.2 km, 47.6 mi) on the Pitchfork Ranch, is the result of redirecting the broad *ciénaga* flow into what became a creek-like incision. This resulted from an effort to avoid flooding two later abandoned agriculture fields, situated down-channel left or on viewer's right. Before this *ciénaga* was damaged, it likely migrated through the entire valley width shown here. Photo: Cinda Cole (2007).

grade (Fig. 3). Since the late 1800s, natural wetlands in arid and semi-arid desert grasslands of the American Southwest and Northern Mexico have largely disappeared (Minckley and Brunelle 2007).

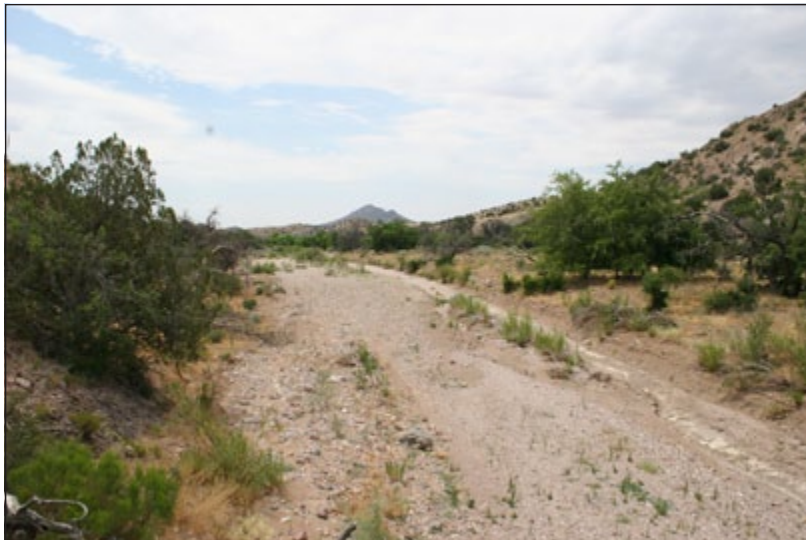
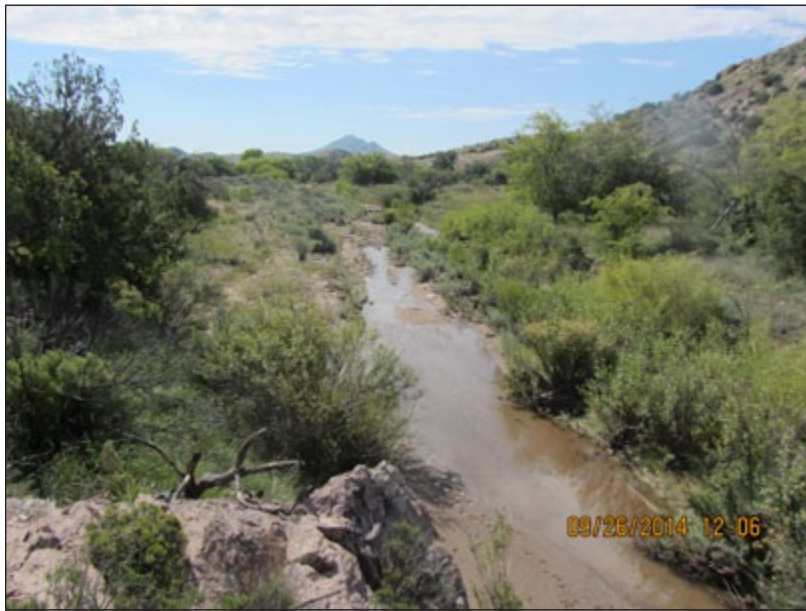
Fig. 4. These photographs were taken from the same location on July 18, 2005, and September 26, 2014. Notice Soldier's Farewell Hill in the background at about 12 km (8 mi) of the Burro Ciénaga and the cholla cactus skeleton, lower left. The top photograph was taken after the boulder baffle was installed and coyote willows were planted, down-channel right, mid-picture. Photos: Cinda Cole (2005 and 2014).

Over the course of the last decade, the *ciénaga* restoration project on the Pitchfork Ranch—still less than half complete—has included the installation of more than 200 grade-control structures that have raised the water table nearly 0.3 m (1 ft), have raised the entire watercourse bed more than 0.3 m (1 ft) throughout the ranch's 14.5-km (9-mi) reach of the Burro *Ciénaga*, have correspondingly raised the level of the surface water, have widened and “shallowed” the channel, have captured 27 Mg (30 ton) of sediment, have increased vegetation, and have caused surface water to extend farther down-channel for a longer period of time before water recedes underground. The results of restoration can be seen from the pair of same-location photographs in Figure 4.

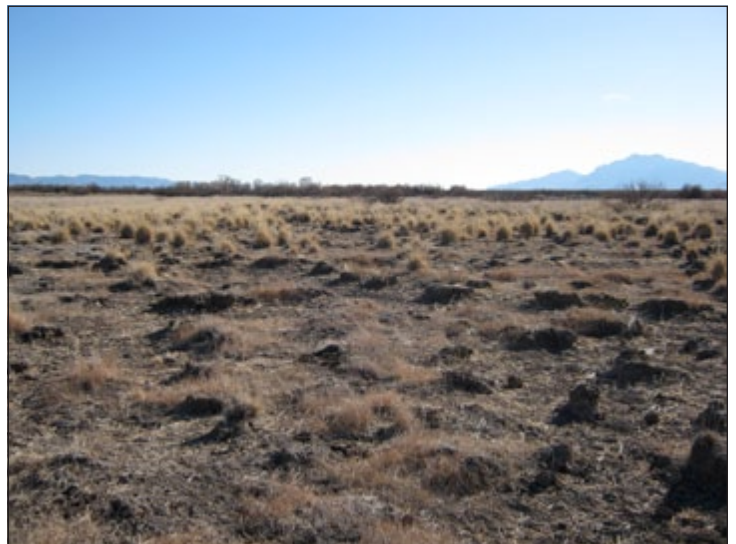
Fig. 5. Former San Simon Cienega on the Arizona/New Mexico border now dead, beyond any possible recovery despite a determined, long-range government effort, since abandoned. Photo: Cinda Cole (2010).

The combination of the above forces had synergistic implications that transformed the entire Southwest, causing desertification that has drastically reduced *ciénagas* and extent of wetlands (Minckley et al. 2013). Review of the papers addressing *ciénagas* suggests the dominant land-surface process in the Southwest today is stream scour, which is the opposite of sheet flow, or slow-moving water, a phenomenon that was far more common just 200 years ago (Hendrickson and Minckley 1985). The current status of *ciénagas* is stark. Since the late 1800s, erosion associated with post-settlement channelization and drawdowns of local water tables have dried up most *ciénaga* environments to a mere 5% of historic *ciénaga* habitat (Fig. 5; Minckley and Brunelle 2007).

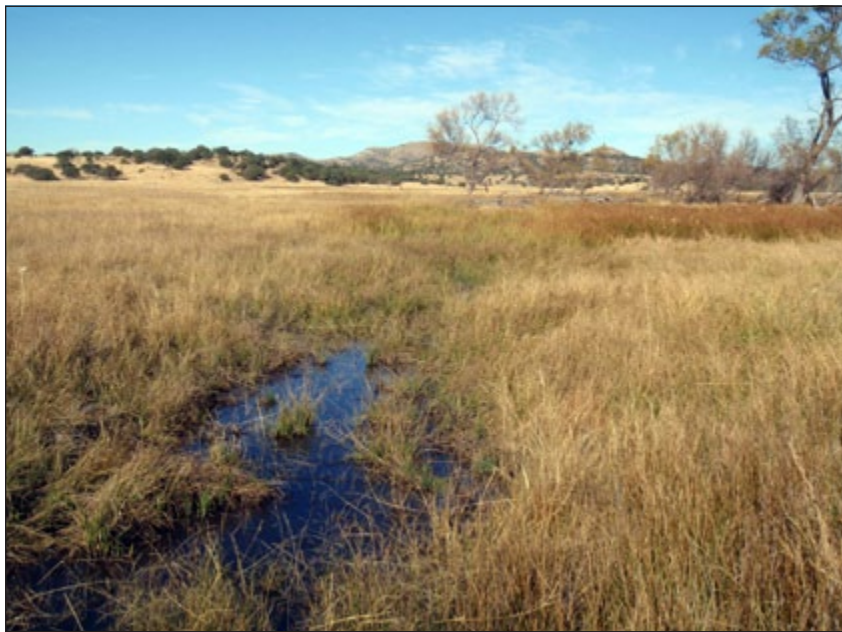
Fig. 7. Cloverdale Cienega, Bootheel region of southwest New Mexico. This is what an essentially undamaged *ciénaga* looks like. Photo: Thomas A. Minckley (2008).

1. Functioning *Ciénagas*. These are *ciénagas* whose structure and function are essentially unimpaired: not seriously incised, often broad and marshy, functioning much as they did before Spanish and Anglo settlement. However, most of these are markedly reduced in size. A mere 26% ($N = 40$ total) of *ciénagas* listed in Appendix B remain intact, and their rarity mandates high-priority management and preservation (Figs. 7 and 8).

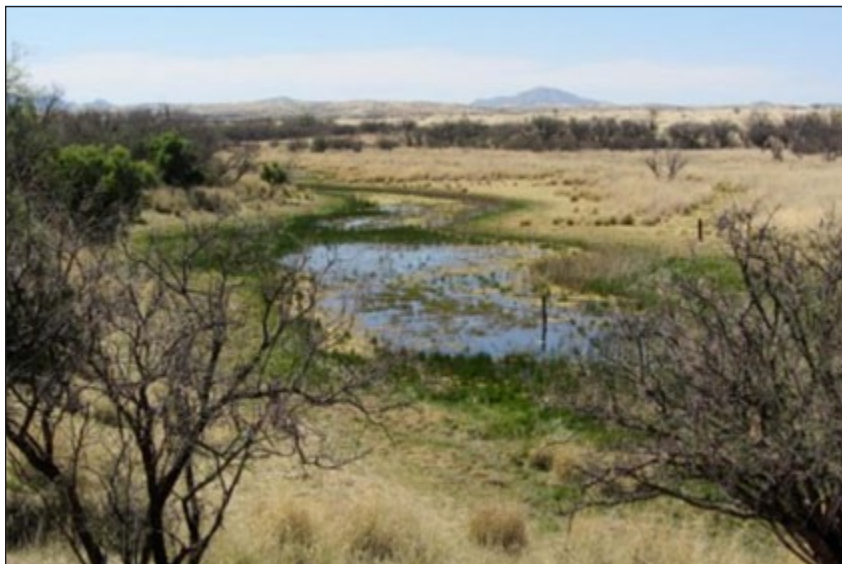
Fig. 8. Cieneguita, Las Cienegas, north of Sonoita, Arizona. With almost no incising, this is a smaller, functioning *ciénaga*. Photo: Karla Sartor (2012).
